Subject: Crawford Street Corporation Site
Preliminary Assessment

Preliminary Assessment

Crawford Street Site Portland, Oregon

Prepared for
Crawford Street Corporation

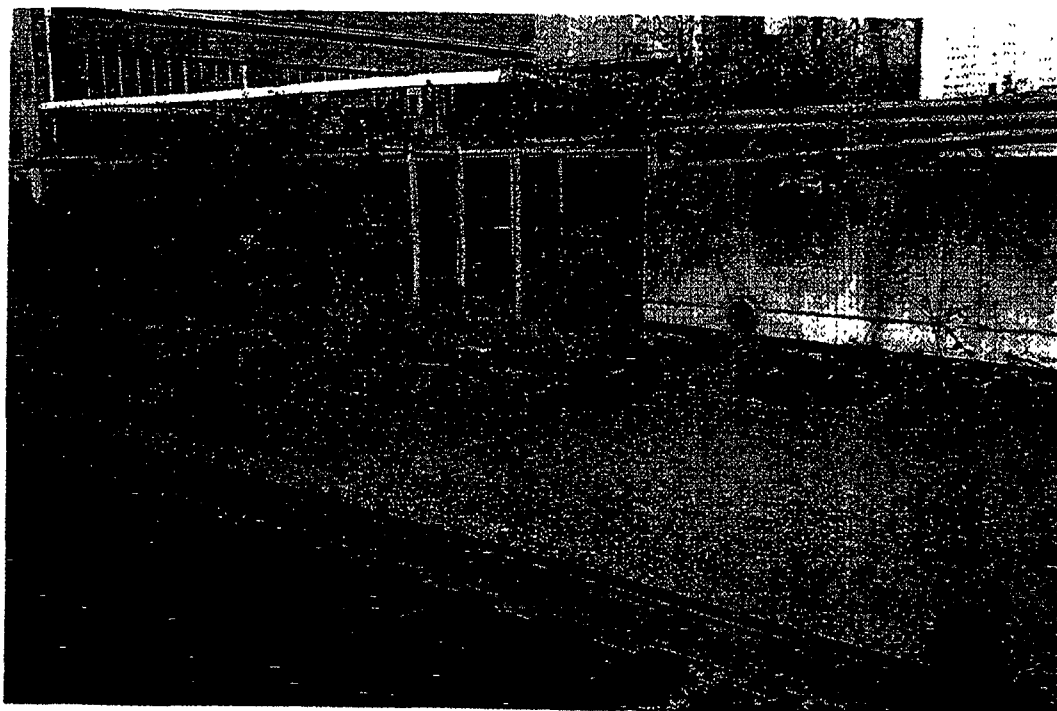
Photo No: 15

Prior to the recent construction of the sand filter/retention box, the water would directly exit the drain pipes and infiltrate into the ground surface near the UPRR rail spur (as shown in the photographs in Appendix A, taken during the site reconnaissance, before the sand filter/retention box was installed). Soil staining was observed at the outlets of the two drain pipes along the UPRR spur during the December 1999 site reconnaissance.

Looking north at drain line outlet from east end of Columbia Forge yard.

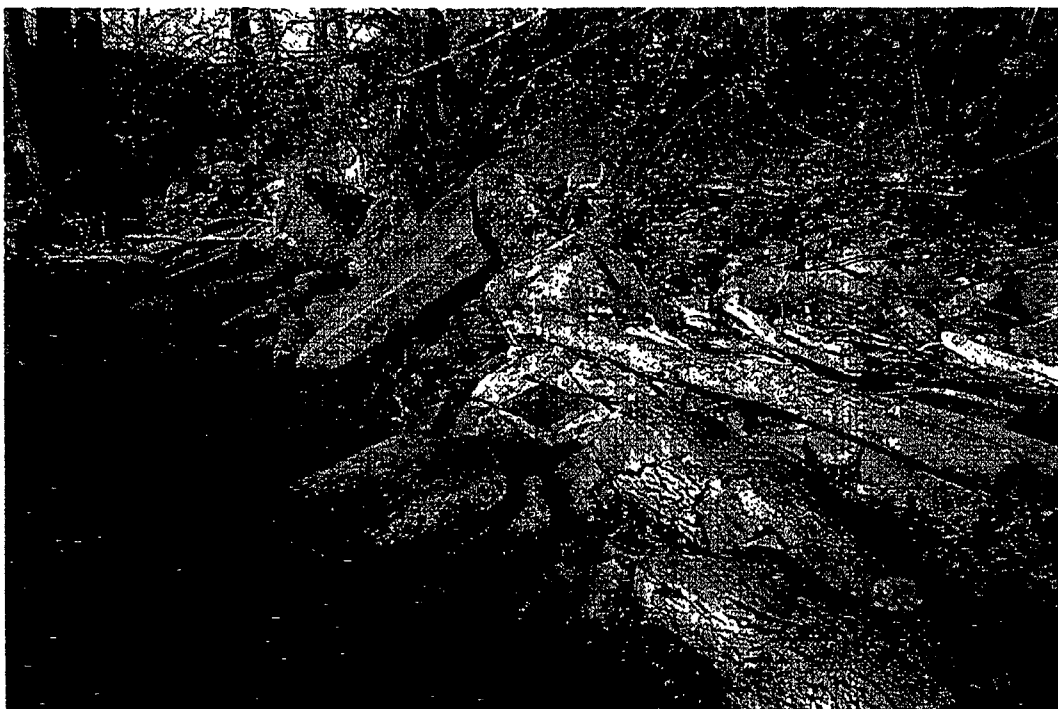
Photo No: 17

The riverbank is vegetated with blackberries and small trees. Most of the bank is covered with concrete debris and logs. Some of the concrete debris is larger than 6 feet with logs greater than 20 feet long. Smaller asphalt debris was also observed on the riverbank. Although the vegetation limited the ability to closely observe, no seeps were observed along the riverbank during the site reconnaissance. A nominal 8-inch diameter concrete pipe was observed protruding from the riverbank about 200 feet east of the western boundary of the CSC site. No evidence of recent flow from the pipe was observed (even after recent wet weather) and the pipe appeared to be associated with previous uses of the CSC site.

Typical river bank conditions.

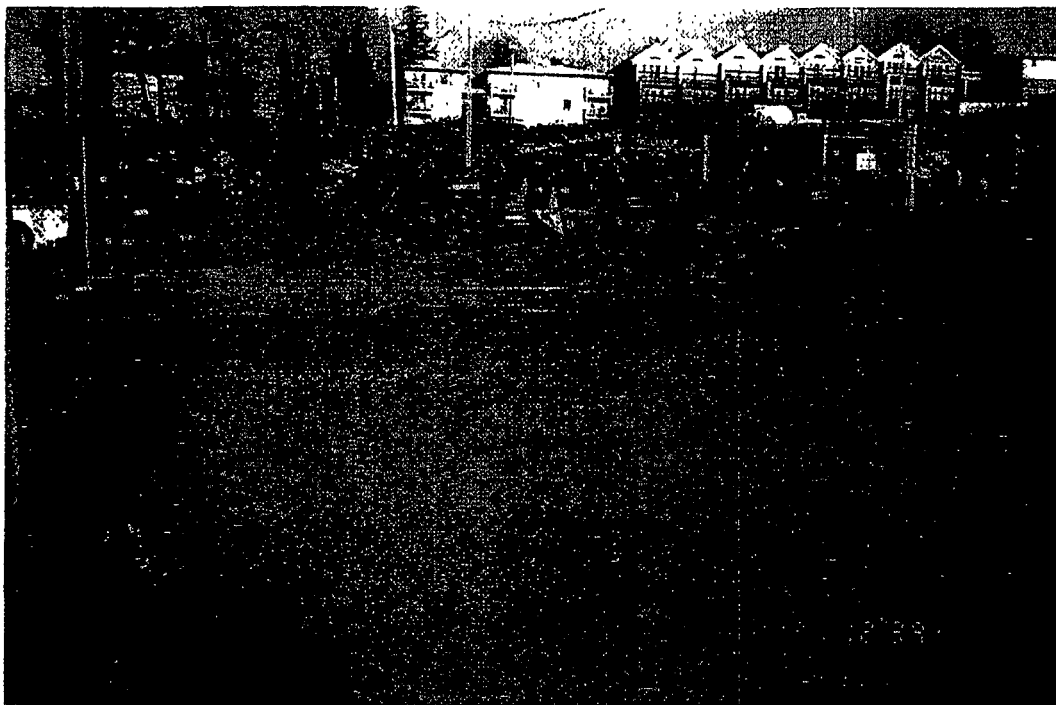
Photo No. 18

Storm water runoff from these up gradient areas flows on to, and across the CSC site. In particular, runoff flows off of the St. Johns Truck and Equipment site and flows on to the Lampros Steel property at the west end of the CSC site, onto the Columbia Forge yard, and onto the Columbia Forge and Lampros Steel yard at North John Street. A sheen was observed on this runoff during the site visit. CSC constructed an asphalt berm along the southern edge of North Crawford Street to reduce the amount of runoff coming on to the CSC site from up gradient properties.

Looking north from north side of Columbia Forge/Lampros Steel yard at St. Johns Truck and Equipment debris yard. Storm water runs from this area, across Crawford Street, and on to and across the storage yard.

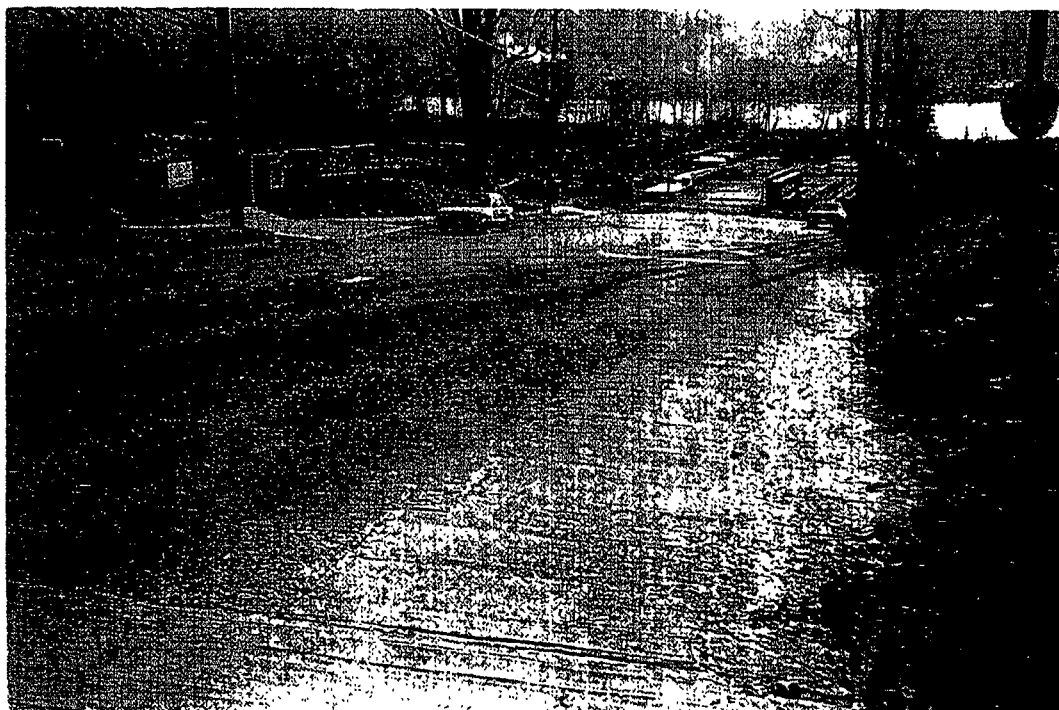
Photo No: 21

The runoff from the up gradient properties continues across the CSC property to the UPRR rail spur where it ponds and infiltrates. During heavy rainfall events, this runoff from the up gradient properties can flow to the west to the City of Portland catch basin at the intersection of North Burlington Street and the UPRR rail spur.

Looking south down North Richmond Street. Storm water flows down this street to UPRR rail spur area and to the Lampros Steel south storage yard.

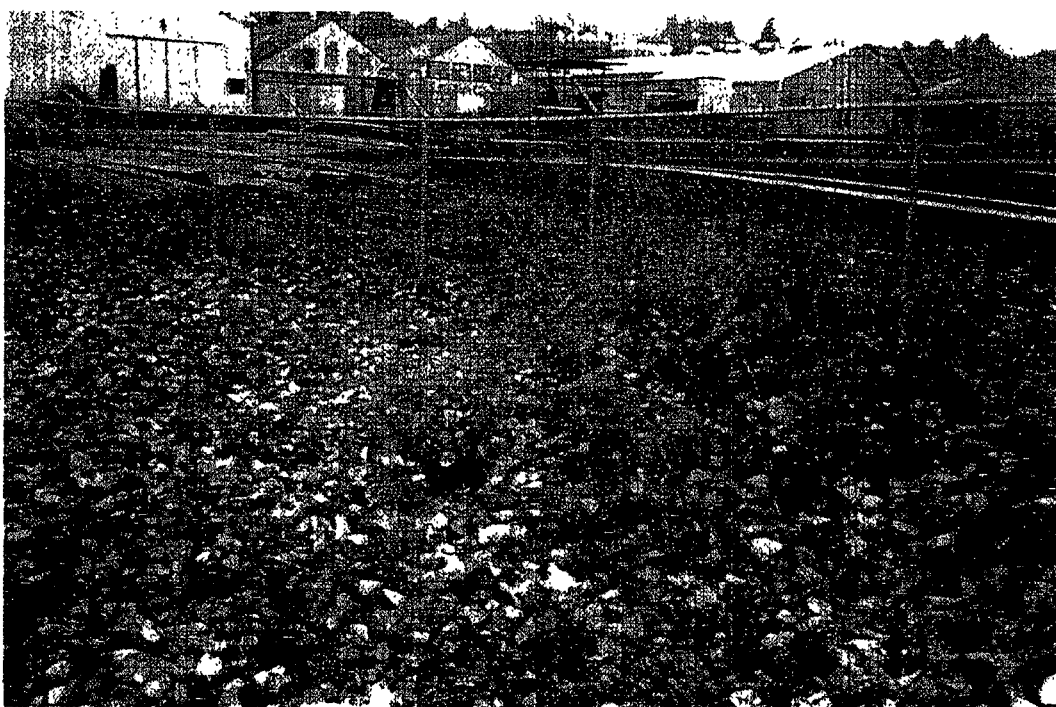
Photo No: 23

Storm water runoff in the eastern portion of this area is directed to a small ditch and wetland area in the eastern area of the BES property. A waste pile containing asphalt debris was observed on the eastern edge of the BES property, adjacent to the CSC property. The Willamette riverbank also contains concrete and asphalt debris at the eastern edge of the BES property.

Looking northeast from City of Portland property west of Crawford Street site. Note asphalt and concrete debris pile on City property

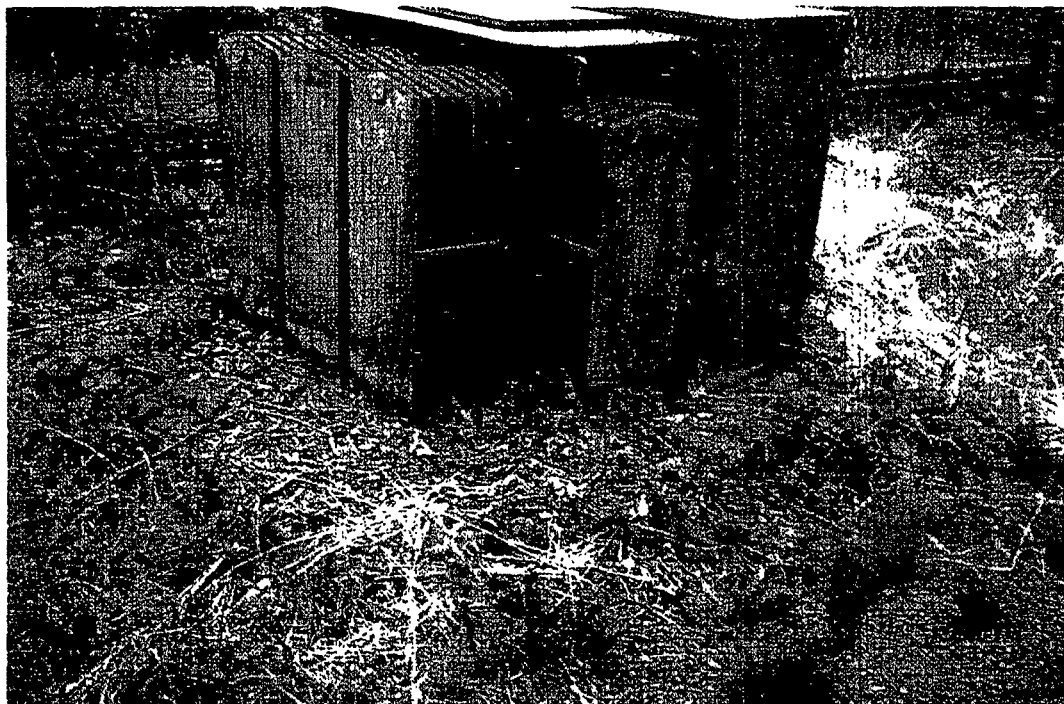
Photo No. 26

An electrical transformer is located on a 5-foot by 5-foot concrete pad in southwest portion of the Columbia Forge operations yard. There was no staining on the exterior of the transformer or the concrete pad or any other evidence of leakage from the transformer.

Transformer in southwest portion of Columbia Forge operations yard. Looking southwest.
